A Guide to
Renovating
the Exteriors of
Older Commercial
Buildings

Prepared by Paul J. Jakubovich and Les Vollmert for The City of Milwaukee, Wisconsin

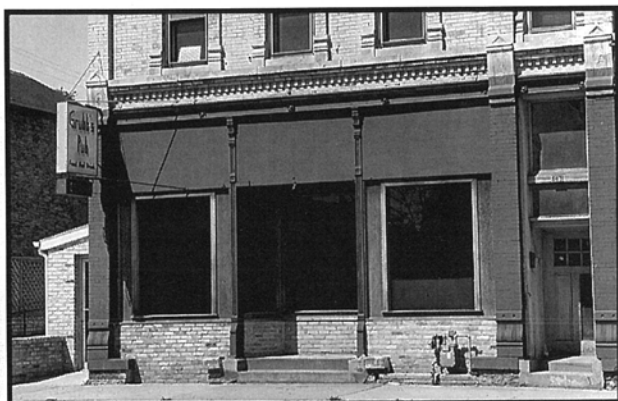
■ A storefront with an exposed cast iron pier and lintel system.

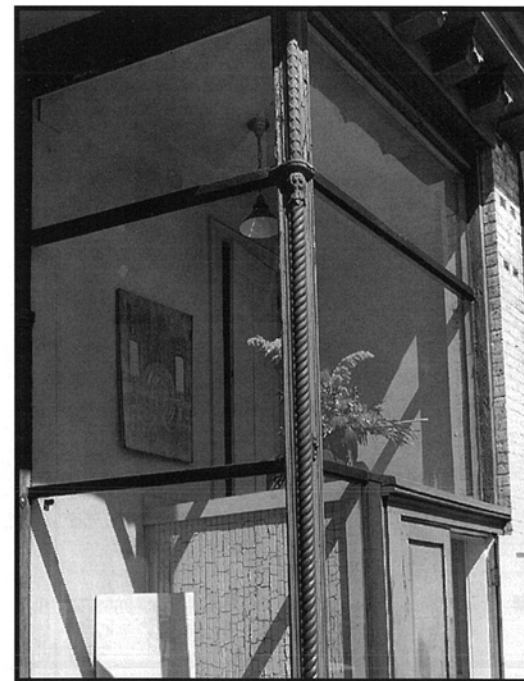
■ A Victorian cast iron glazing bar system like this one adds character to the storefront and should be preserved.

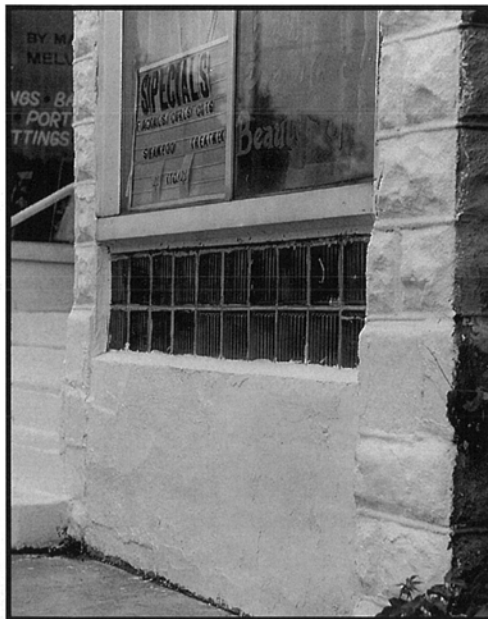
■ Glass block basement window inserts look out of character on older commercial buildings, and their use should be avoided in very visible locations, especially on storefronts.

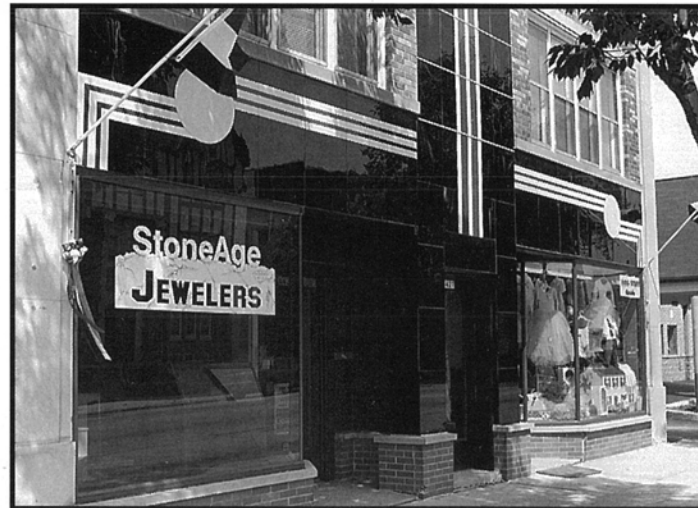
■ This storefront was clad in structural glass in the 1930s or 1940s when it was a highly fashionable material. Although once common, such storefronts are now rare and surviving ones should be preserved.

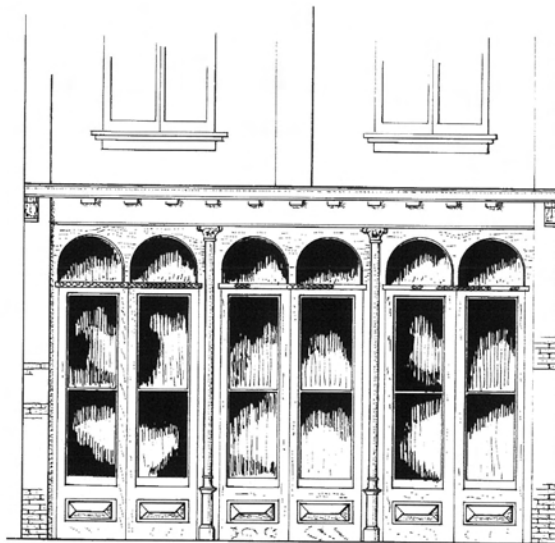
■ This drawing shows a typical door front store with its three pairs of double doors.

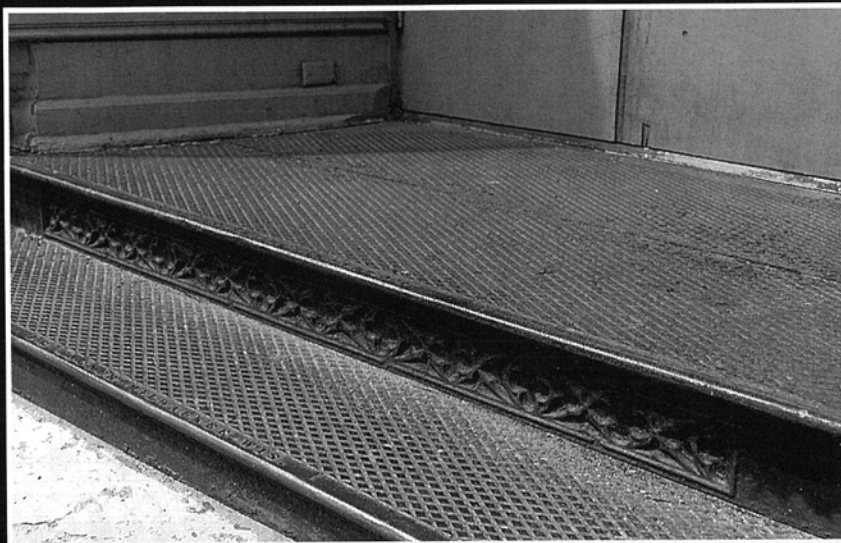
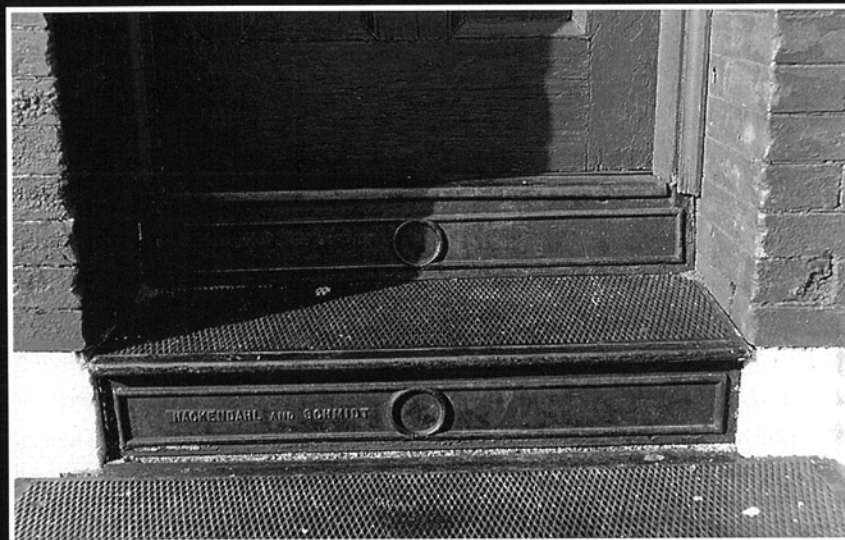
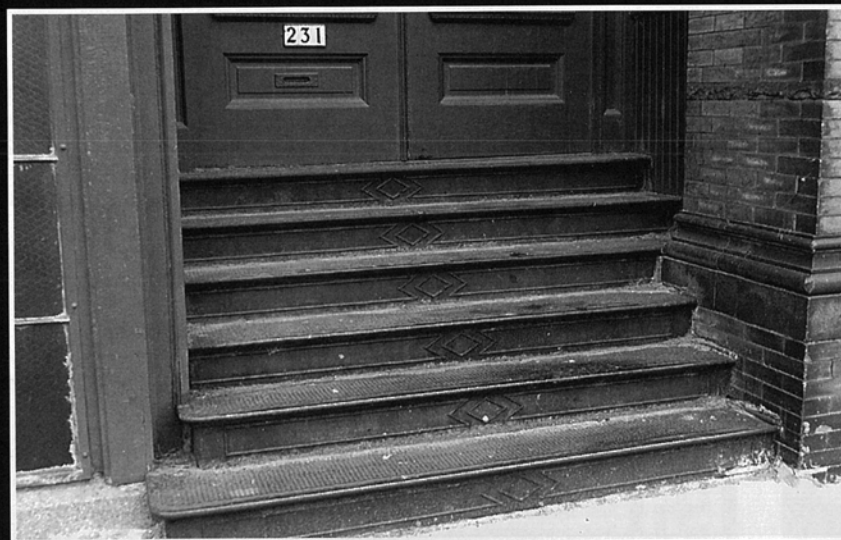
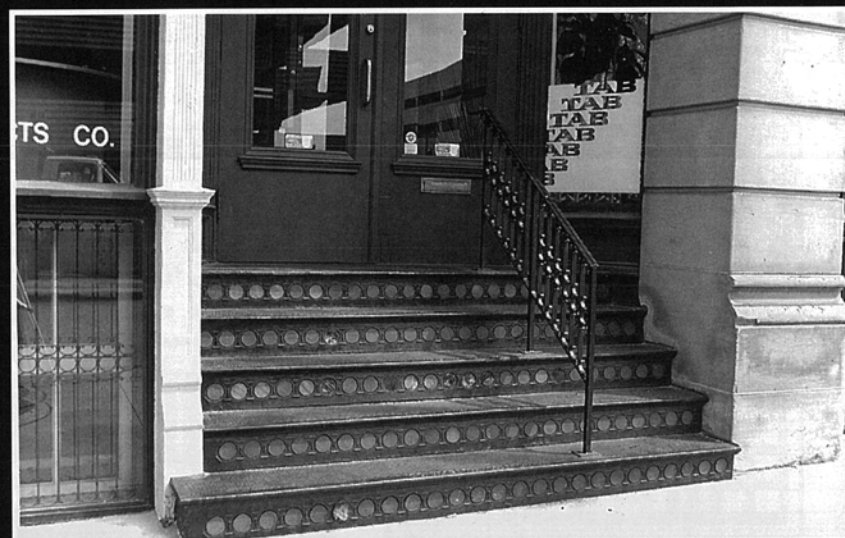
■ Metal stoops were once common in Milwaukee, and many examples still survive in good condition after 100 years of use.

and then given a metal primer coat followed by at least two coats of a good quality metal paint. A two-part epoxy paint is preferable.

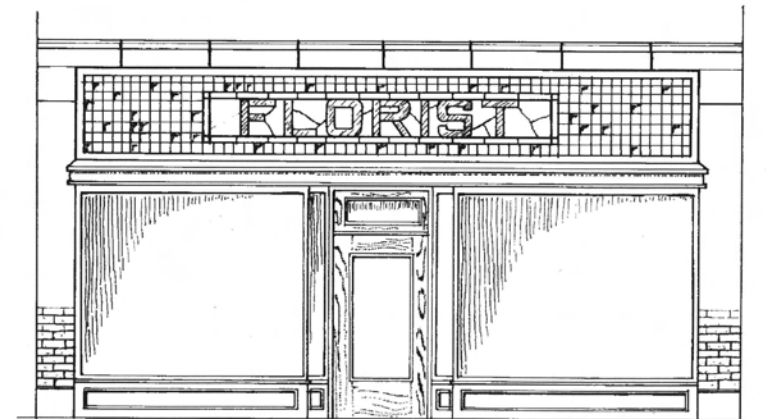
■ This drawing shows a typical storefront where the transom is used as a sign.

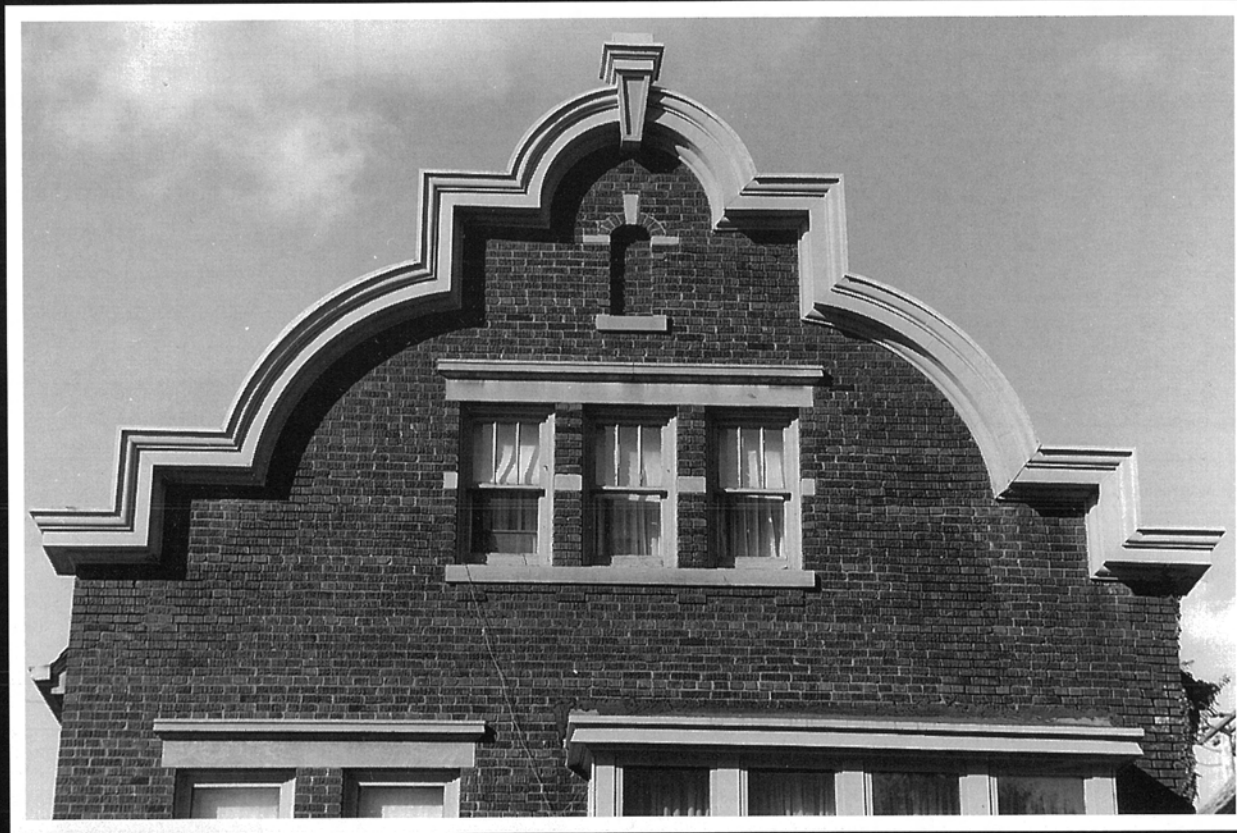
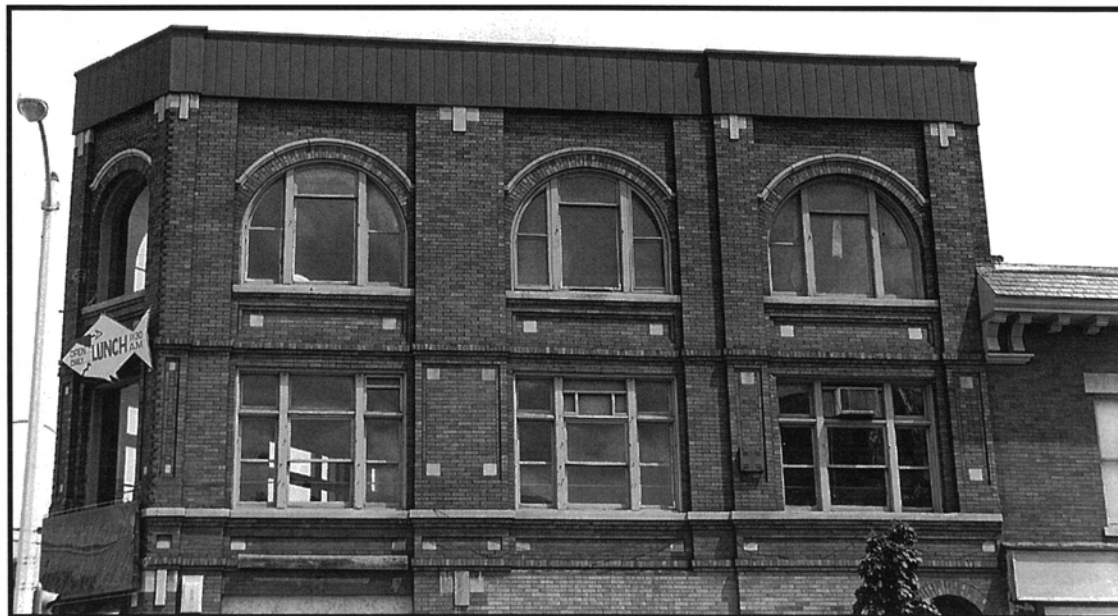
■ Too many buildings have had their cornices needlessly removed when they could have been repaired. The aluminum cladding, installed to cover the scars created when the cornice was removed, just calls attention to the fact that this building has lost an important architectural feature.

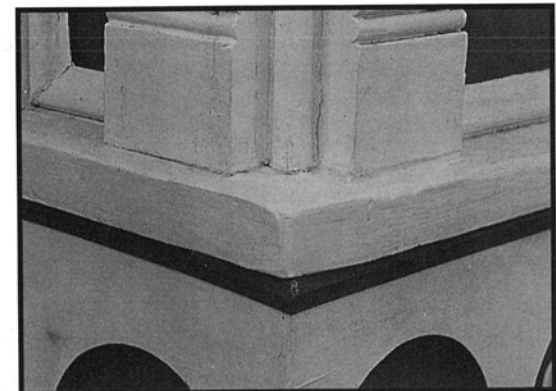
■ After painting, the repair is invisible.

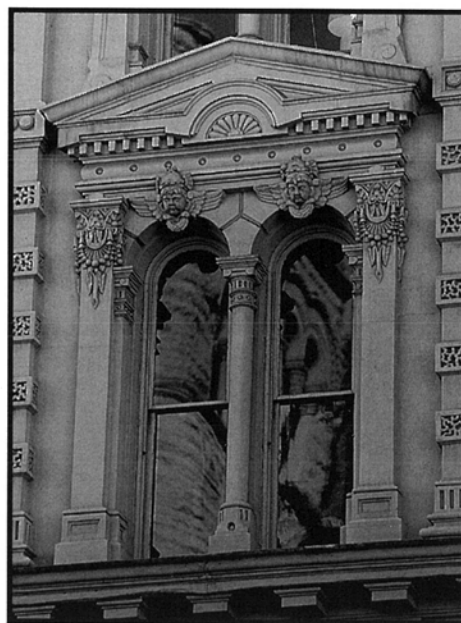
■ Commercial wooden windows, such as these 120-year-old units, were made to last. They should be repaired and retained if at all possible. They can be made more energy efficient by adding either interior or exterior storm windows.

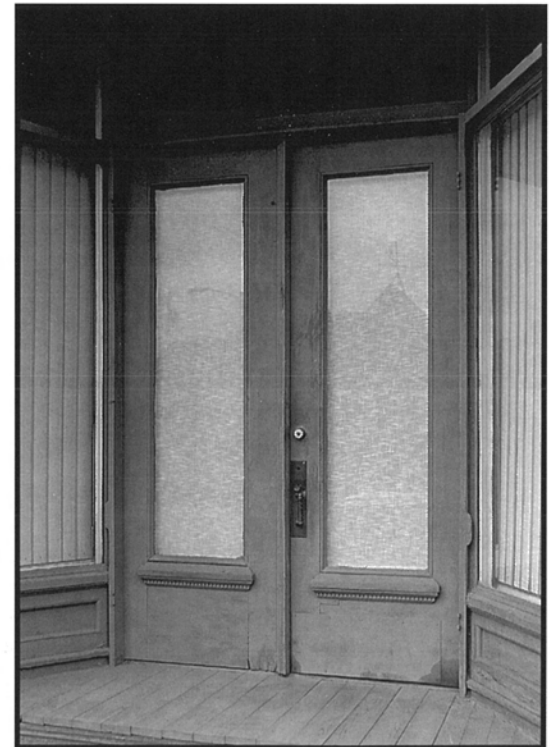
■ Although this storefront door is in poor condition, it can be easily restored, probably for less than it would cost to replace it.

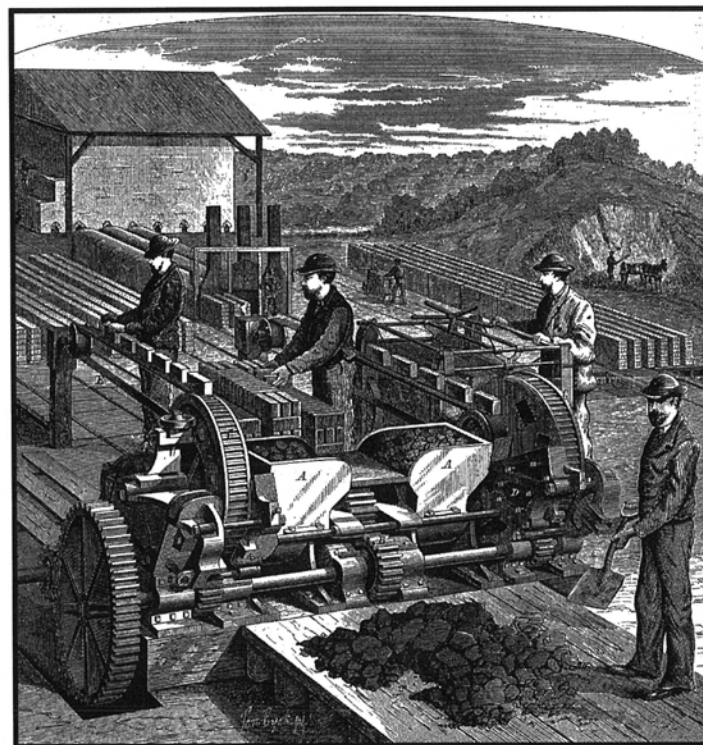
■ This 1870s engraving of the brick-making process shows clay being excavated from a hillside and loaded into a horse-drawn wagon. Clay, water and some other minor ingredients were then shoveled into the brick making machine which mixed and formed the clay into brick shapes. Before being fired in a brick kiln, the so-called "green" brick were allowed to air dry in the sun in long rows. In the background, workers are shown building a kiln to fire the air-dried brick.

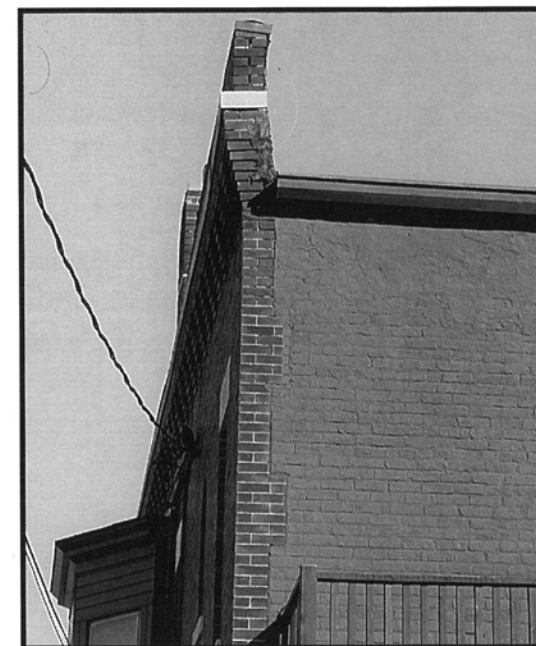
■ This buckling parapet wall will need to be dismantled down to the roofline and rebuilt using the salvaged brick.

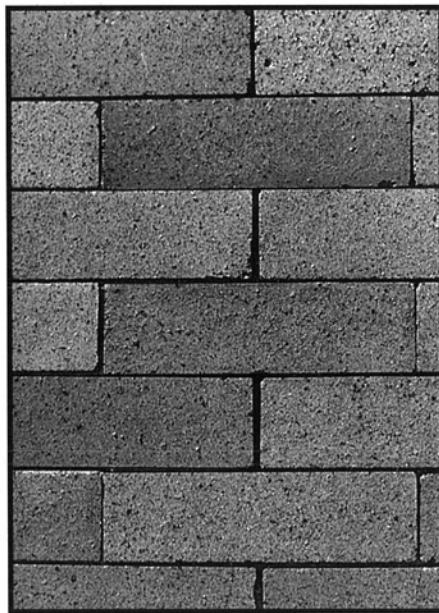
■ Power grinders and tuckpoint saws should not be used to remove mortar from knife edge joints like these.

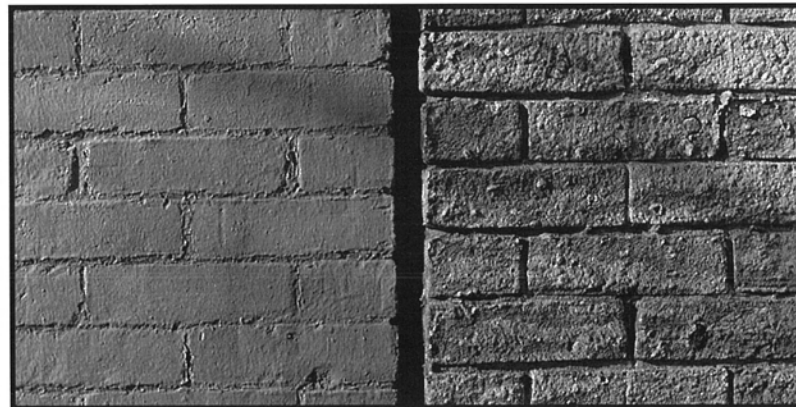
■ The sandblasted brick on the right is pitted and spongy-looking. It will absorb moisture, attract dirt, and powder away. The damage done by sandblasting is irreversible. The hard, smooth surface of the unsandblasted brick on the left will withstand the effects of weathering unharmed for centuries. The paint can be removed from the brick on the left using chemicals without harming the brick.

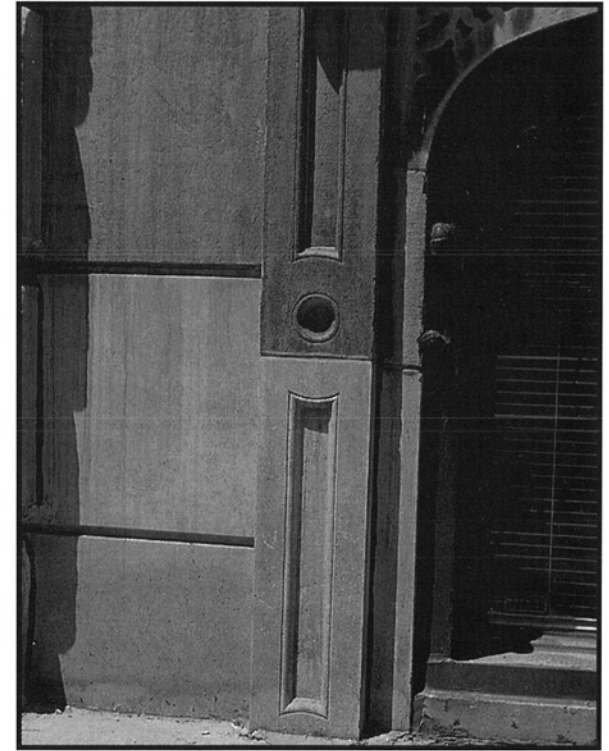
■ The new stone pieces on the right were installed to replace the severely deteriorated old stone shown on the left. Over time, the new stone will weather to more closely match the old stone in color.

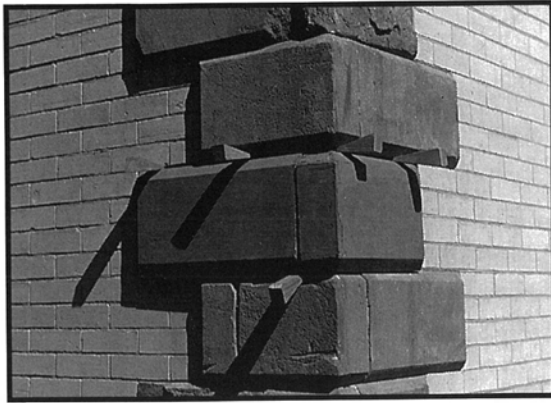
■ New colored cast concrete pieces are being installed to replace these deteriorated red sandstone quoins.

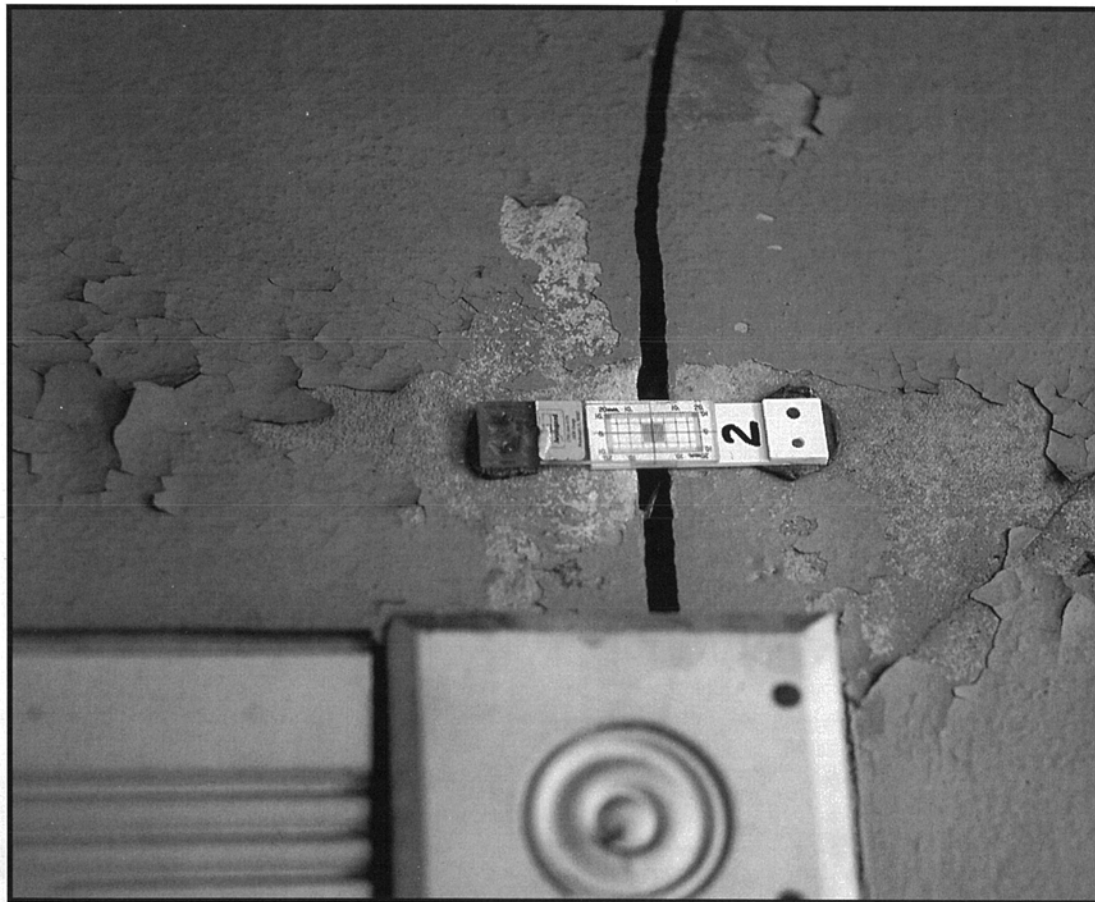
■ A crack meter will measure movement in a wall.

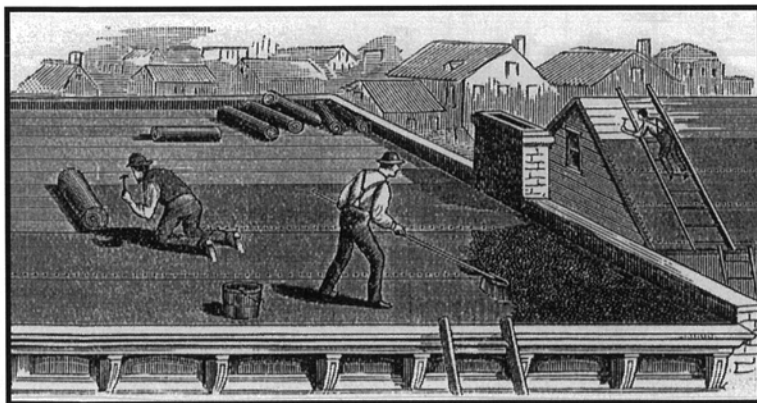
■ This drawing shows built-up roofing being installed on a commercial building in the late nineteenth century.

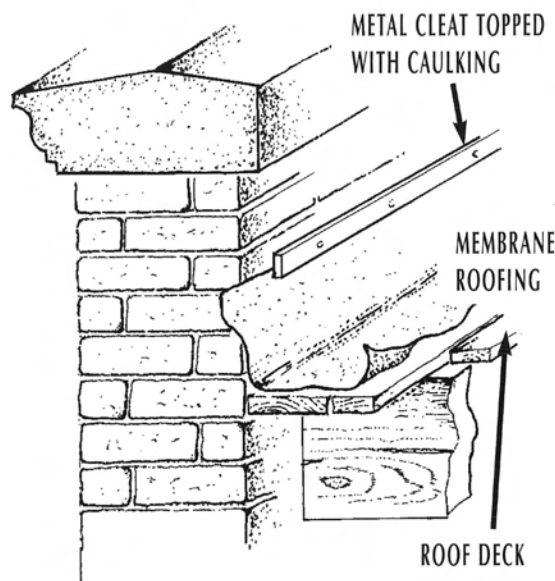
■ The cleat and caulk method of installing membrane roofing should be avoided because it is prone to leaking at the point where it is attached to the parapet wall.
